# SEISMIC EVALUATION REPORT

**Tillamook Volunteer  
Fire District**

**Seismic Assessment for  
Fire Station 71**  
2310 4th St.  
Tillamook, OR 97141

December 16, 2022  
22057.00

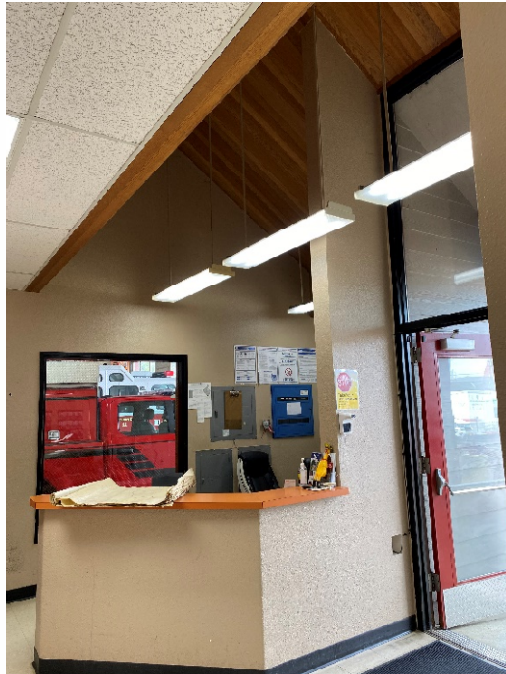
**Image 5: Main Entry with Unbraced Lighting & Glazing**

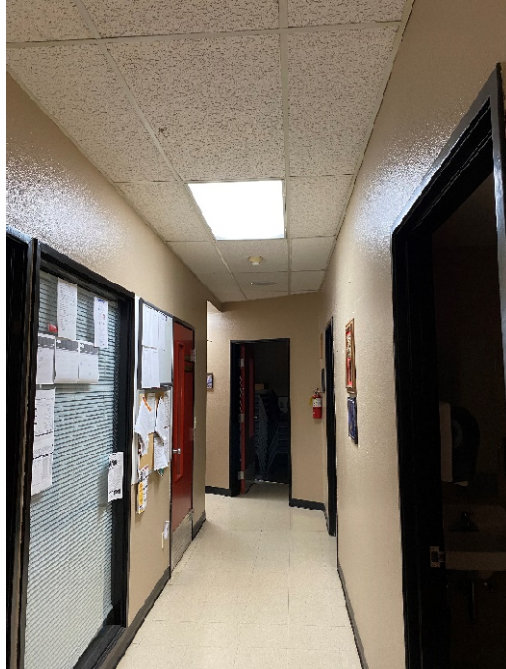
**Image 6: Interior Corridor Ceiling**

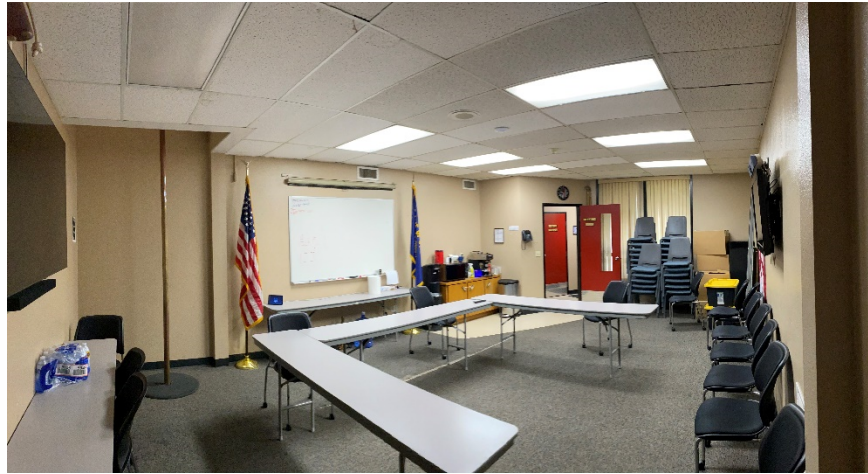
**Image 7: Interior Board Room Ceiling**

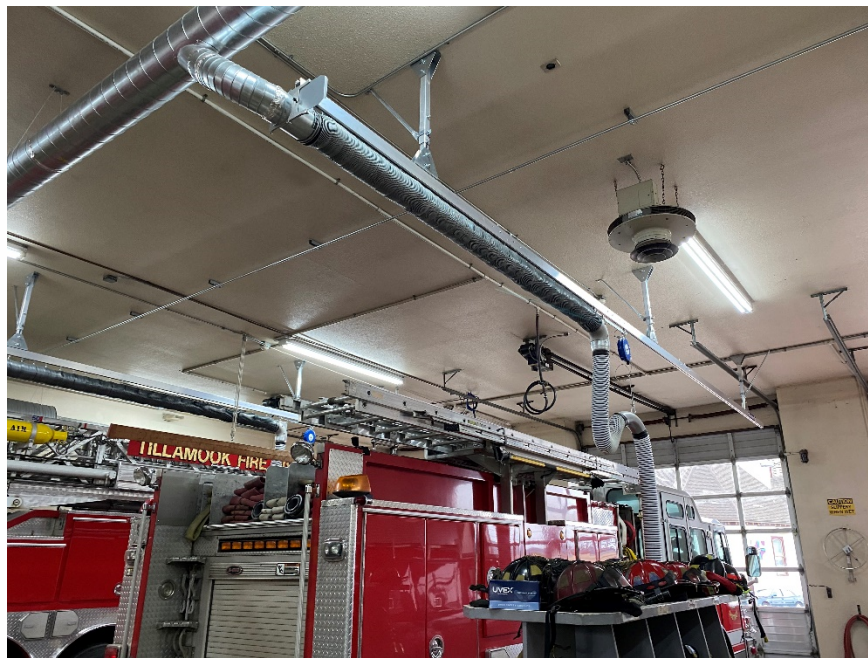
**Image 8: Unbraced Duct in Apparatus Bay**

<b>TABLE 4 – NONSTRUCTURAL Deficiencies &amp; Strengthening Measures continued</b>			
<b>Item Number</b>	<b>Component Type</b>	<b>Deficiency</b>	<b>Strengthening Measure</b>
<b>N11</b>	Vibration Isolators	Equipment mounted on vibration isolators is not equipped with horizontal restraints or snubbers nor with vertical restraints to resist overturning.	Provide horizontal and vertical restraints to resist lateral displacement and overturning.
<b>N12</b>	Heavy Equipment	Floor-supported equipment weighing more than 400 lb. is not anchored to the structure.	Provide adequate anchorage to equipment weighing more than 400 lb.
<b>N13</b>	Duct Bracing	Rectangular ductwork larger than 6 ft <sup>2</sup> in cross-sectional area are not adequately braced for seismic loading.	Provide lateral bracing at rectangular duct work.

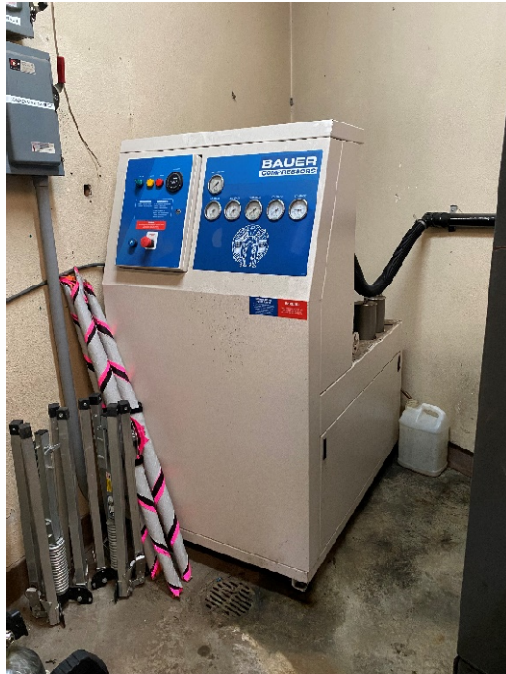
**Image 9: Unanchored Equipment**

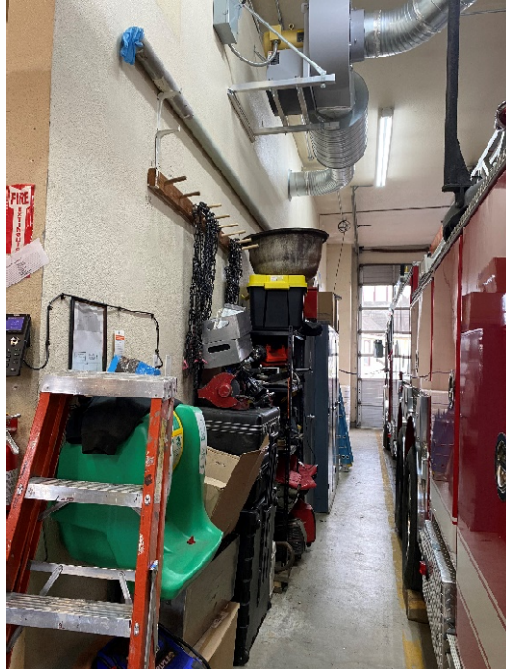
**Image 10: Unbraced Cabinets & Shelving**
