# SEISMIC EVALUATION REPORT

**Tillamook Volunteer  
Fire District**

**Seismic Assessment for  
Fire Station 71**  
2310 4th St.  
Tillamook, OR 97141

December 16, 2022  
22057.00

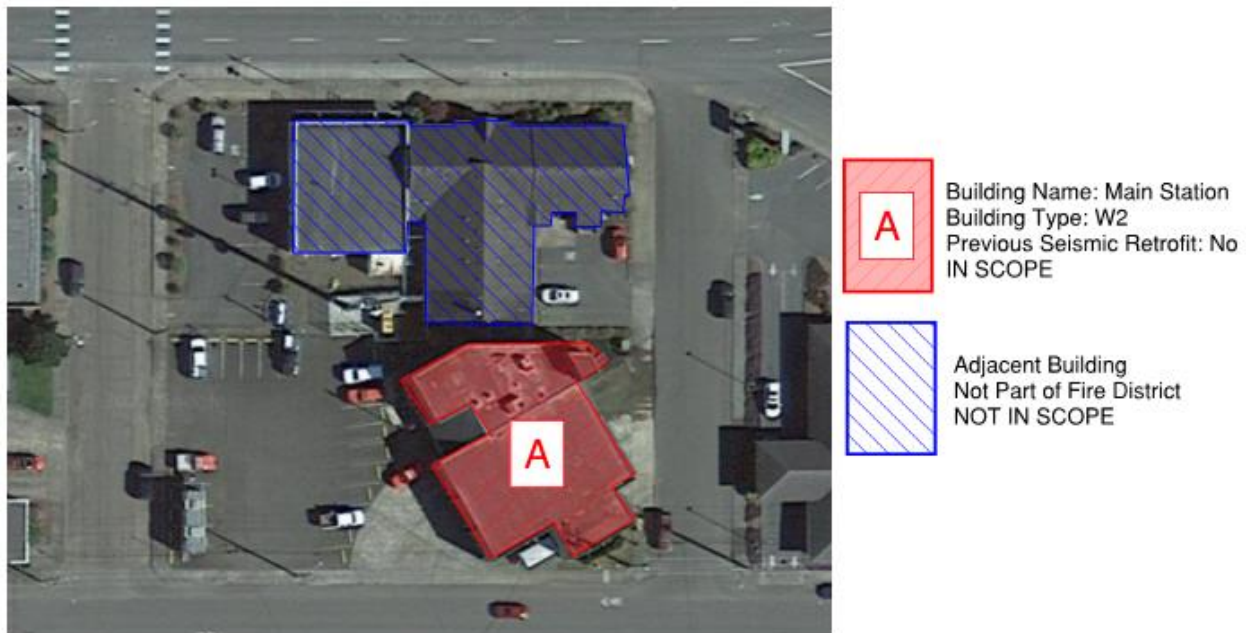
**Figure 2: Building Part Map**

Station 71 is a two-story, wood-frame building originally constructed circa 1980. The building is irregular in plan, with a large single-story apparatus bay adjoining a two-story structure of offices, meeting rooms, and housing spaces. The two-story component is trapezoidal in plan, measuring approximately 40 feet by 68 feet, with a maximum roof height of approximately 22 feet. A 33-foot-tall hose tower adjoins this component to the north and measures approximately 8 feet by 12 feet in plan. The main apparatus bay shares its west wall with the two-story component and is 52.5 feet by 78 feet in plan, with 17.5 feet by 36 feet additional garage off the east side. The maximum roof height for the apparatus bay and garage is approximately 18 feet. See **Figure 2** for a Building Part Map and **Appendix A** for photos of the building.

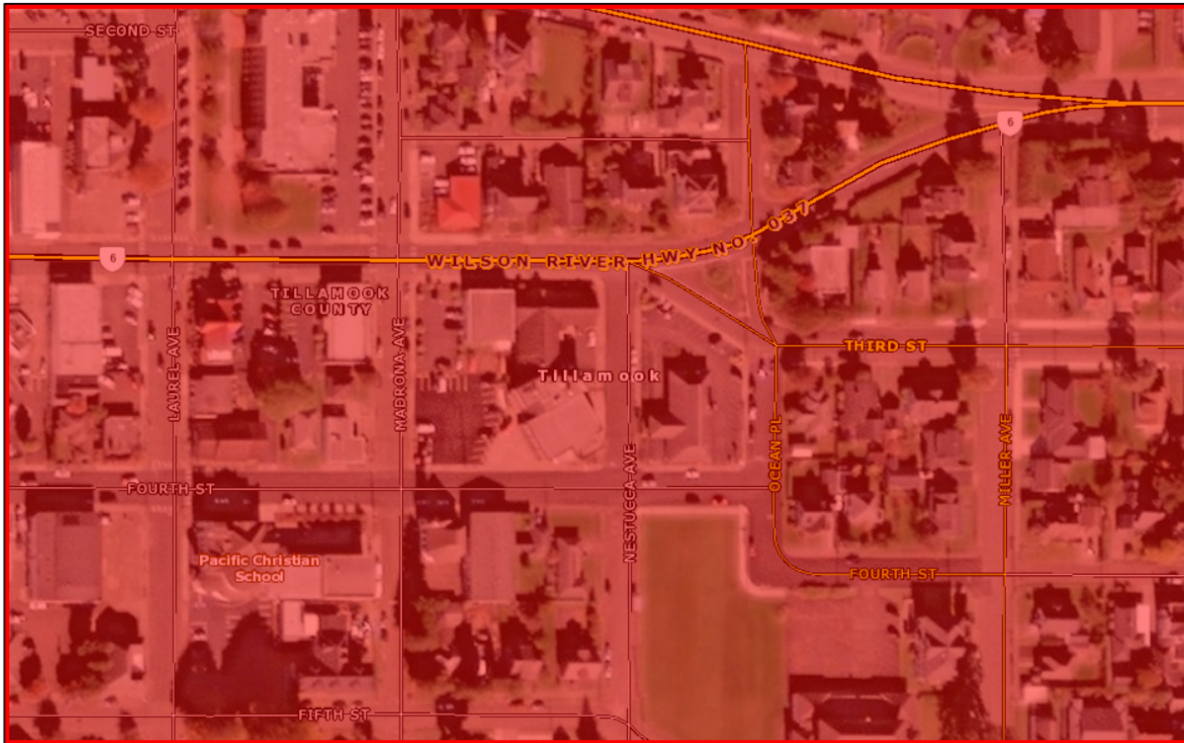
## Tillamook FD - Liquefaction & Fault Hazard

The site is identified as a high liquefaction potential location and deep foundations (i.e., piles) will be used to mitigate this hazard.
